CAPITAL IMPROVEMENTS AND STREET MAINTENANCE COMMITTEE OF THE CITY OF WAUSAU

SUBJECT: Closing McClellan Ramp – Improvements to Jefferson

Re: *Forensic Restoration Report for the McClellan Parking Ramp
Wausau, WI
Walker Consultants Project # 21-004750.12*

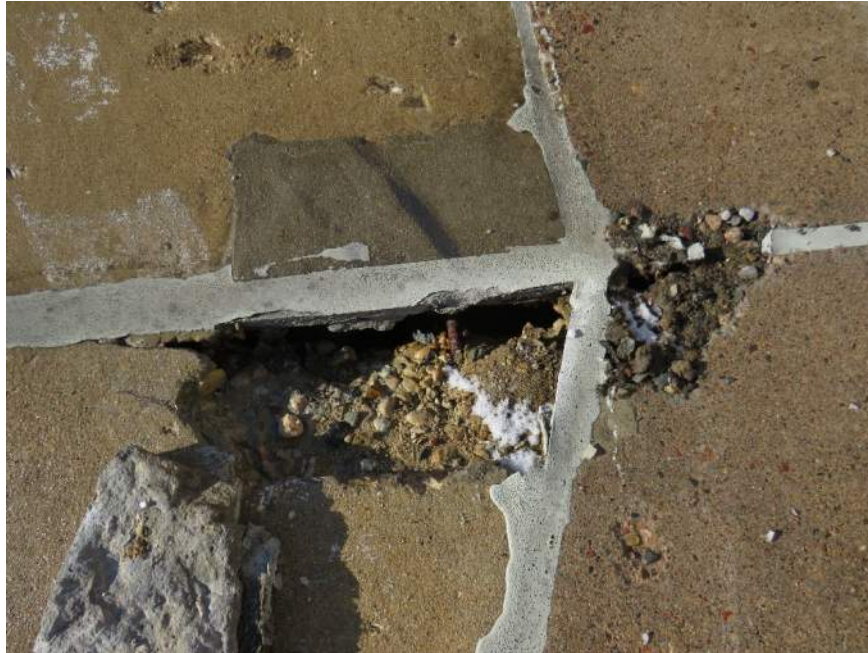
1. Spalled concrete was observed throughout the facility. Concrete spalls deeper than a 1/2” are defined as a trip hazard, per ADA, and should be repaired. Refer to Photo 1.

Photo 1. Trip hazard at spalled floor concrete. Source and Annotation: Walker Consultants (Photo taken 12/8/2022).

Repair spalled concrete to eliminate trip hazards.

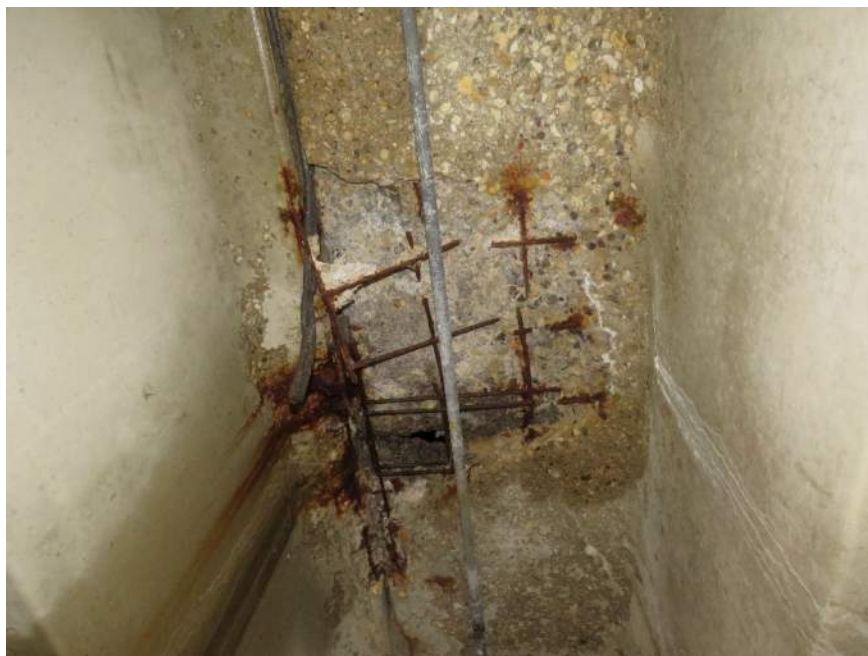
2. Delaminated/spalled concrete was observed on the underside of the double tees. Refer to Photo 2.

Photo 2. Spalled Concrete at ceiling. Source and Annotation: Walker Consultants (Photo taken 12/8/2022).

Repair delaminated and spalled concrete. Knock down loose overhead concrete.

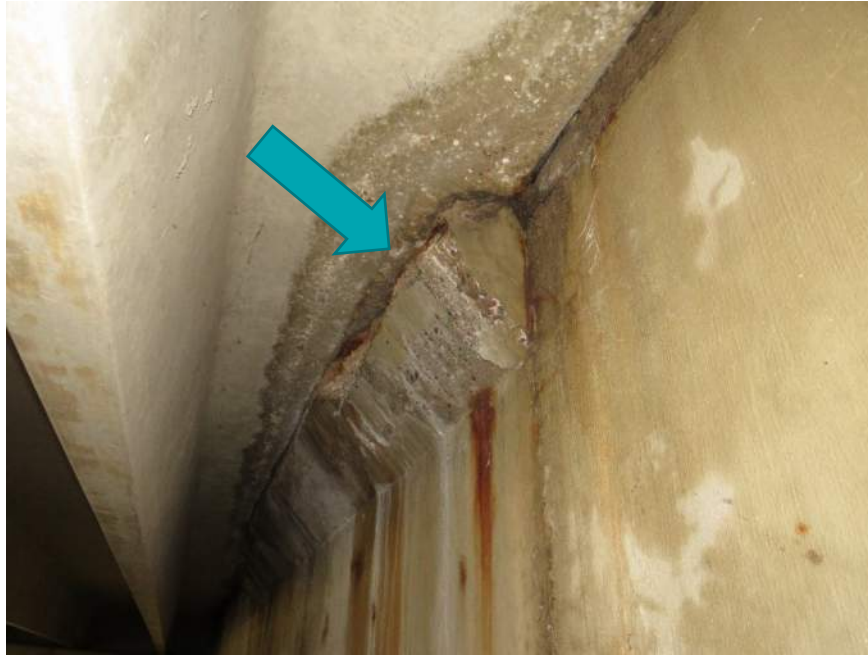
3. Delaminated/spalled concrete was observed at the wall haunches reducing the bearing area that supports the double tee. Refer to Photo 3.

Photo 3. Spall at concrete haunch. Source and Annotation: Walker Consultants (Photo taken 12/8/2022).

Repair concrete wall haunch to restore bearing surface.

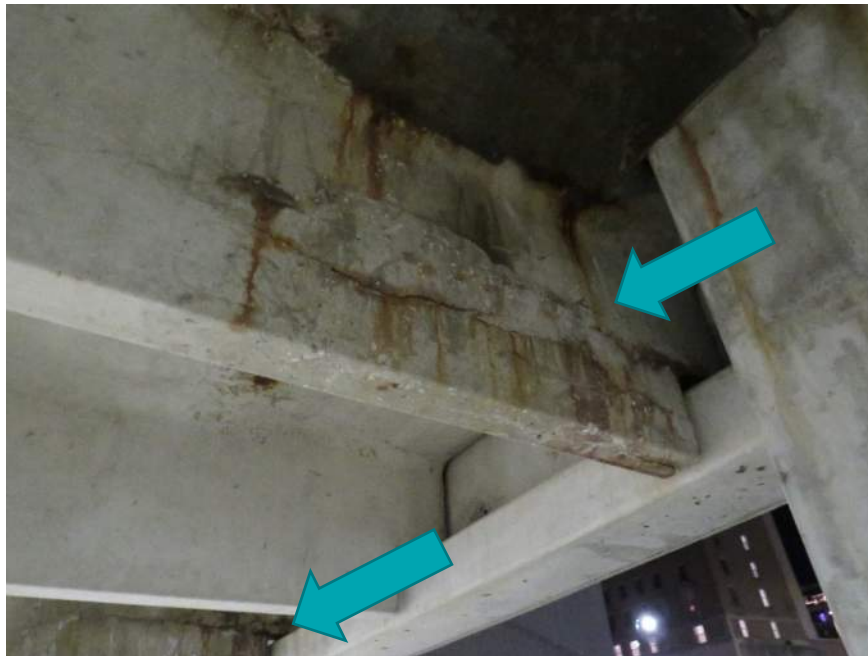
4. Advanced stages of deterioration of the double tee stems were observed at isolated locations. Advanced deterioration observed includes delaminated concrete and cracking along prestressed tendons with rust stains originating from the distressed area. Possible debonding or corrosion of the bonded prestressed tendons may be present. Refer to Photo 4.

Photo 4. Advanced deterioration at double tee stem. Source and Annotation: Walker Consultants (Photo taken 12/8/2022).

Shore double tees that exhibit an advanced stage of deterioration.

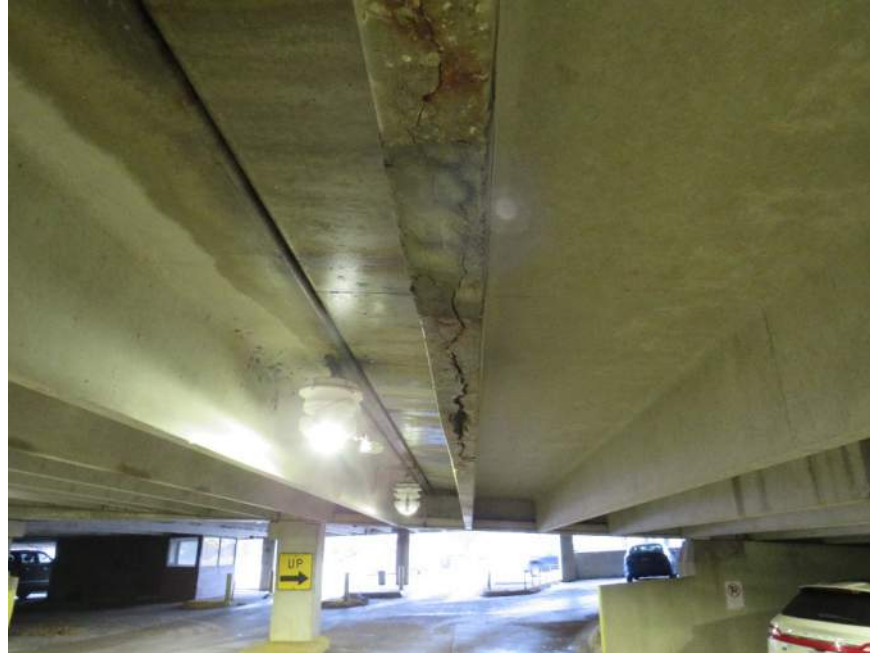
5. A wide crack was observed at the center of an isolated double tee stem. The depth of the crack was approximated to be thirty percent (30%) of the depth of the stem. Debonded prestressed tendons are suspected at this location. Refer to Photo 5.

Photo 5. Cracking down the center of double tee stem. Source and Annotation: Walker Consultants (Photo taken 12/8/2022).

Install supplemental reinforcement at double tee stem.

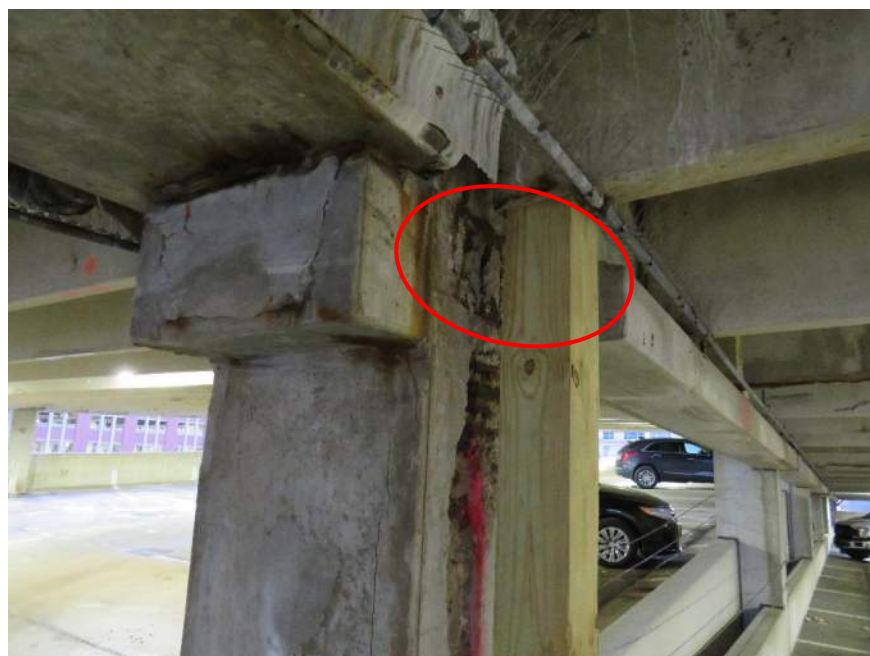
6. At an isolated location a haunch at a concrete column was observed to be failed. The double tee at this location is currently supported by a timber post. Refer to Photo 6. The subsequent levels below did not have a timber/shoring post to transmit the load to the grade level.

Photo 6. Failed/missing concrete haunch. Double tee is supported by timber post. Source and Annotation: Walker Consultants (Photo taken 12/8/2022).

Provide timber shoring on levels below the failed haunch to transfer loads directly to the on-grade level.

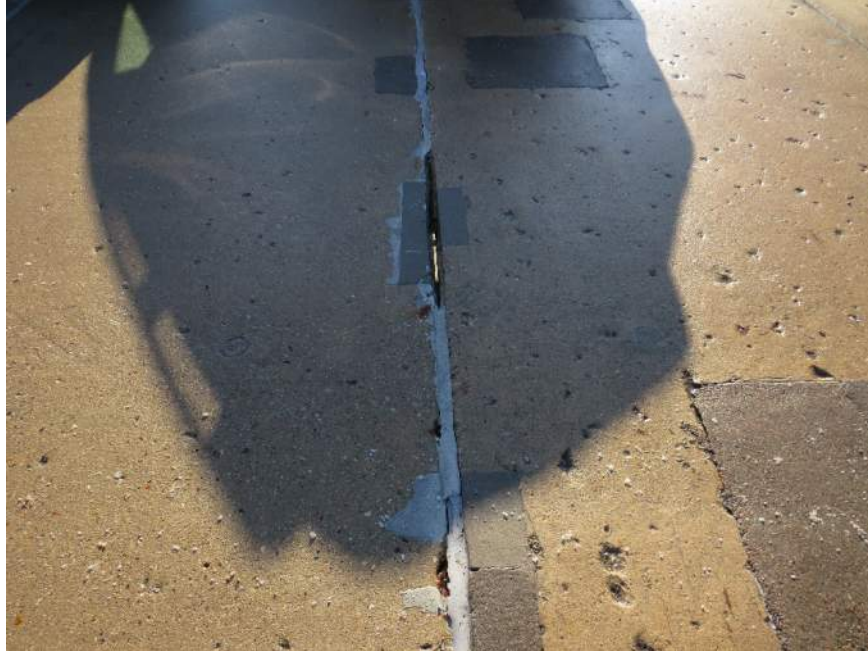
8. Sealants were observed to be in poor condition throughout the facility. The sealants were observed to be weathered with adhesive failures. Refer to Photo 7.

Photo 7. Section of sealant missing, and adhesive failure at double tee joint. Source and Annotation: Walker Consultants (Photo taken 12/8/2022).

Replace failed sealants as needed.
